HOW TO DIAGNOSE A FAILED T'CON BOARD - HOW TO REPLACE A T'CON BOARD

DIAGNOSING A FAILED T'CON BOARD

T'CON REPLACEMENT

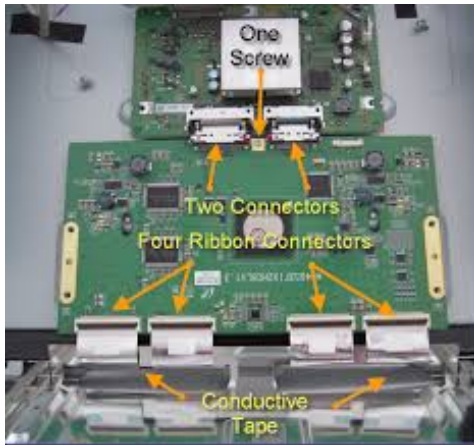
Sony T'Con board

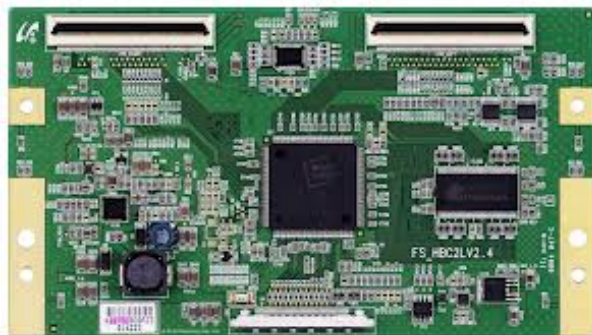
Samsung T'Con board

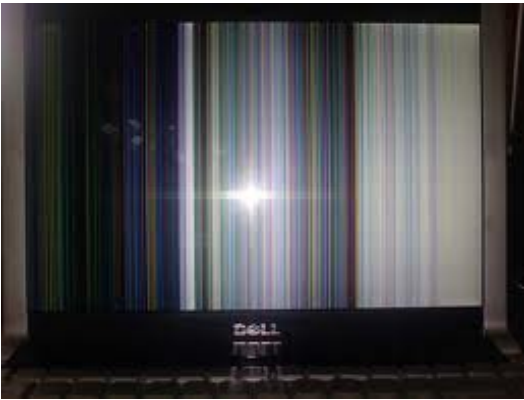
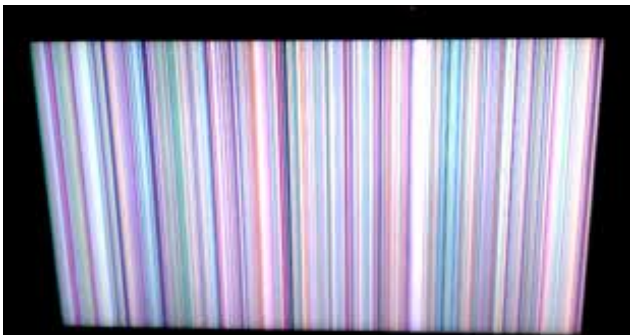
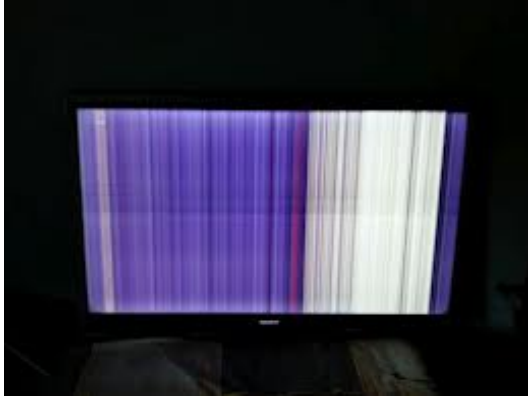
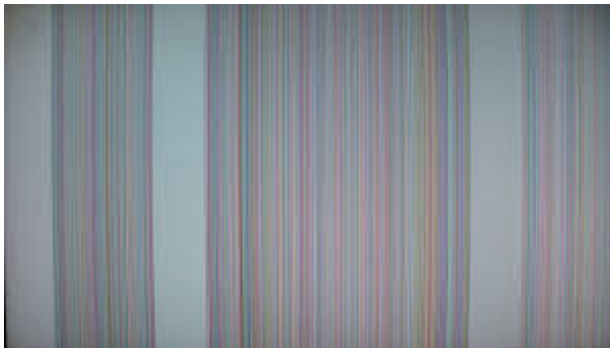
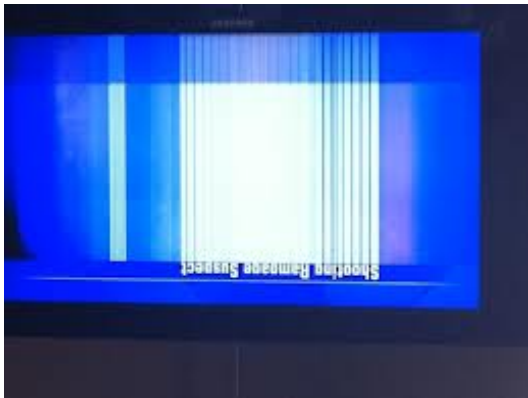
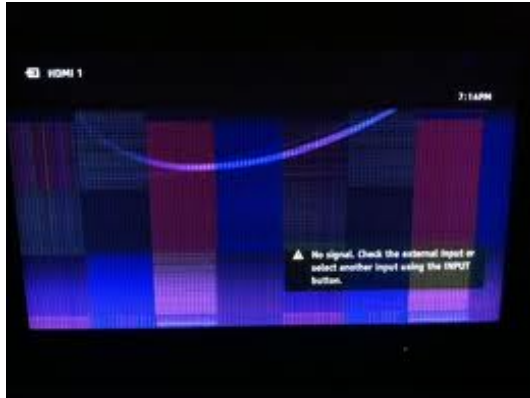
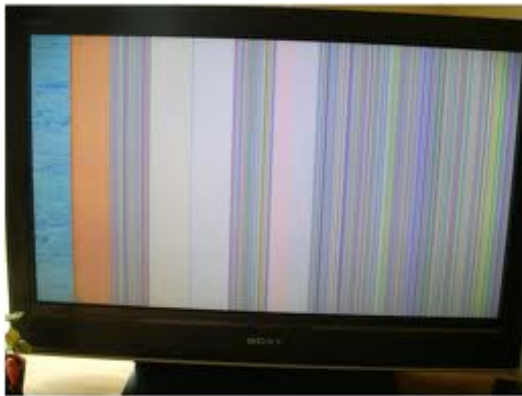
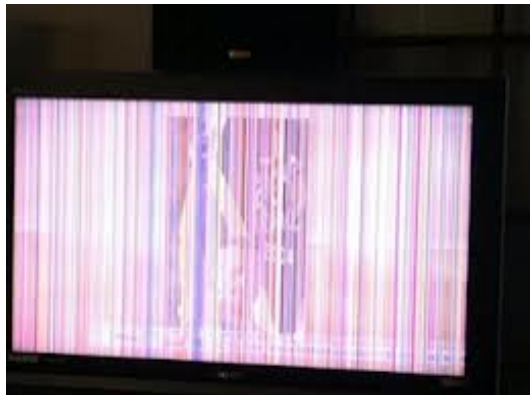
T'CON FAILURES

Failures in the timing control circuits of the T'Con can produce symptoms of absolutely no video or generate lines and patterns that usually cover all or a substantial part of the screen. Determining if the T'Con is the cause of a 'No Video' condition is a bit more difficult since there are no indications on the screen to analyze. Many of the Sony TV models over the last few

years will detect a T'Con that has completely failed. The communications data between the video process circuits and the T'Con will cease to communicate, if the T'Con fails completely. This will cause the TV to shut down and display a diagnostic code, indicating a failure of the T'Con. Not all chassis designs have this feature and it is not found on older models. The typical scenario when this failure arises is for the technician to bring a video process board to the repair location. It is usually safe to assume that the problem lies on the T'Con board, if the replacement video board does not give a solution to the problem since it is highly unlikely that a replacement board with the same failure was received. One trick to check most T'Cons for functionality is to loosen the LVDS connector at the T'Con while unit is turned ON. Handle the LVDS connector with care and be certain to fully release the lock tabs. Gently rock the cable in and out of the connector while observing the screen for any response. Depending on the chassis, the symptoms of the screen may be gentle white flashes, intermittent coloured lines, or a screen full of random patterns. The idea at this point is to provoke some kind of response on the screen. Another helpful procedure is to rapidly heat and/cool the T'Con with a hot air device or circuit coolant and watch for patterns appear on the screen.

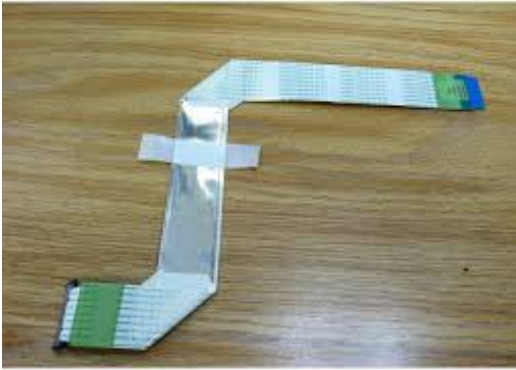
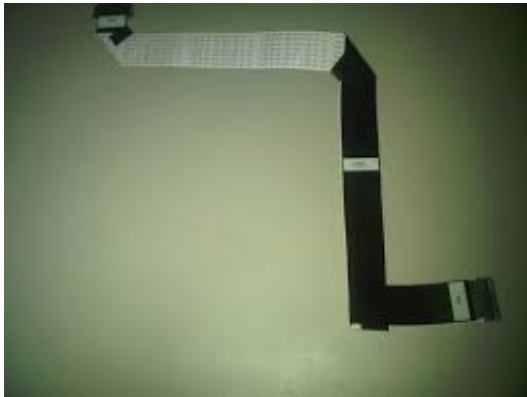
LVDS CABLE

Although the problem with LVDS cable or connectors can generate symptoms of T'Con failures this usually tends to be intermittent and wiggling of the connectors will usually provoke a change in the symptom on the screen. LVDS cable and connectors have become rather robust over the past few years. Technicians who damage them cause most problems and this is generally quite oblivious upon close examination.

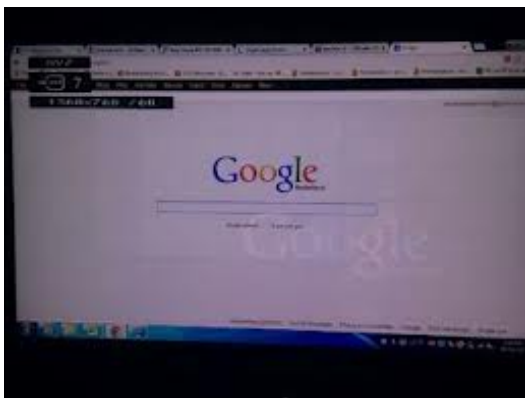
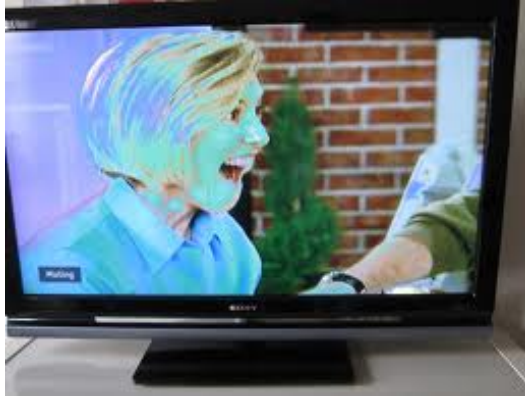
Some LCD panel failures could possibly mistaken for T'Con board issues. Other than damage to the LCD glass, most panel failures are isolated to a particular area of the screen. Since the T'Con disperses the pixel data to groups of line and column drive IC's situated on the outer edges of the panel, it is unlikely that more than one of these IC's would fail at the same time. Multiple columns of struck on or stuck off pixels are therefore, more likely to be the fault of the T'Con circuits. The same applies to a single row of lit or unlit pixels. The T'Con simply cannot cut out a single line of information.
